Composite Cylinder-Head Gaskets and Damage Analysis

Tips and Practical Information No. 3

Composite Cylinder-head Gaskets – The Classical Approach to Cylinder-head Sealing

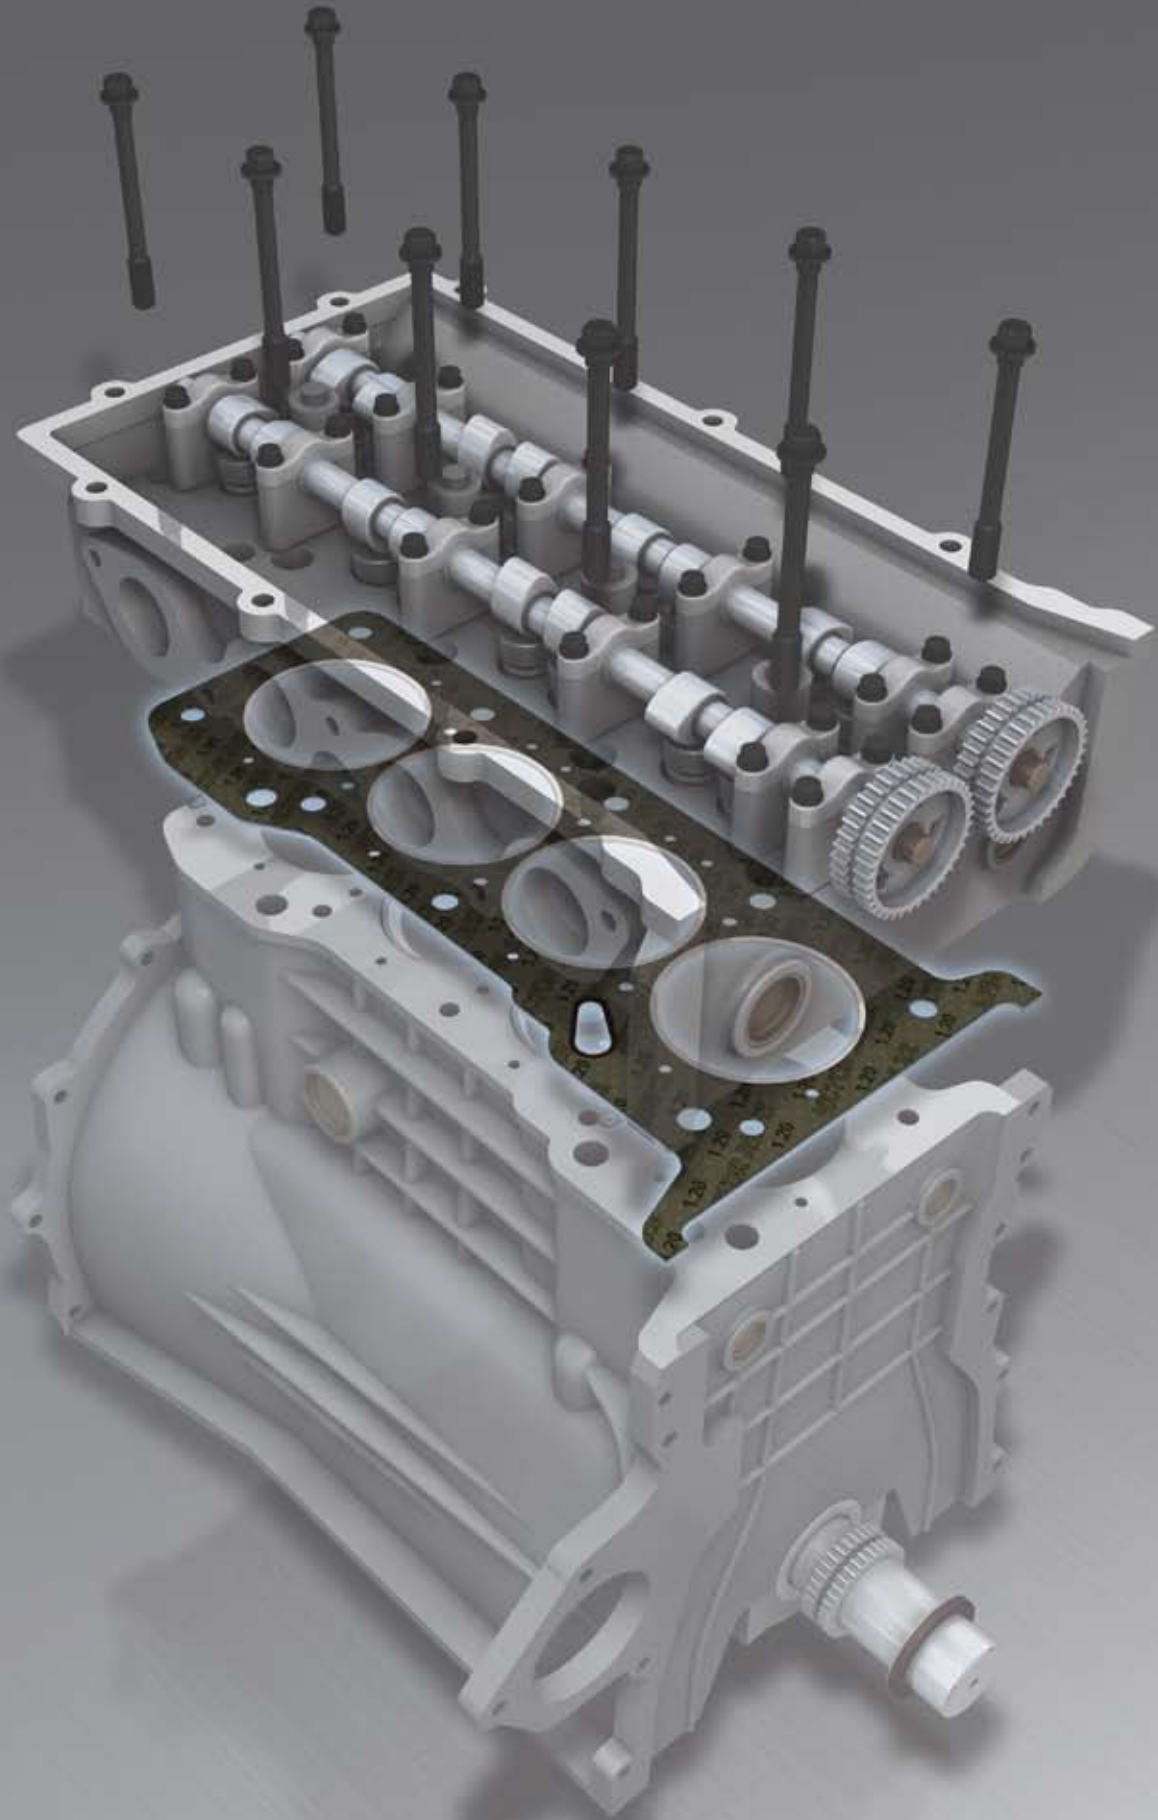
Classical composite head gasket with tanged metal carrier sheet, composite material rolled onto both sides, impregnation, fire rings, and Viton element.

The classical composite head gasket is a compressible flat gasket. It consists of a tanged metal carrier sheet, onto which the composite material is rolled on both sides, i.e. engine block and cylinder head. Metal beads (fire rings) seal the combustion chamber and protect the sensitive composite material from overheating. The material surface is impregnated to prevent the gasket swelling when it comes in contact with liquid media such as oil, water, or antifreeze. So-called Viton elements of elastomer materials permit a partial increase of mounting surface pressure in the vicinity of oil pressure channels.

Due to the mounting surface pressure, the material is deformed slightly so that it adapts optimally to the sealing surfaces. Gaskets with low elastic recovery properties require very high bolt clamping forces for good sealing. Hereby, the minimum web width is approx. 6 mm to withstand the elevated pressures and temperatures during combustion.

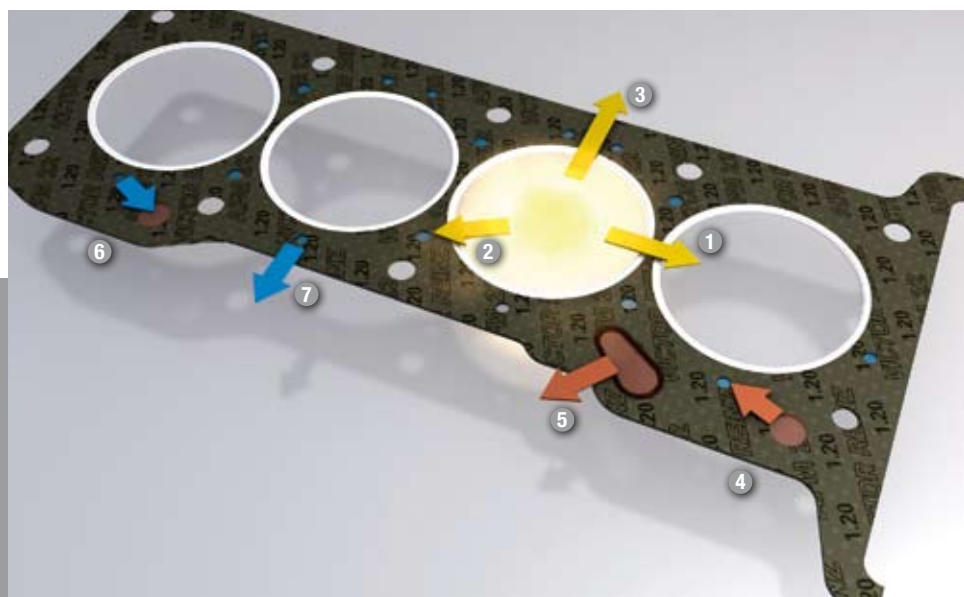
◀ Typical media leakages with composite cylinder head gaskets.

- 1 Gas leakage between combustion chambers
- 2 Gas leakage from combustion chamber to coolant circuit
- 3 Gas leakage to the environment
- 4 Oil leakage to the coolant circuit
- 5 Oil leakage to the environment
- 6 Water leakage to the lubricant circuit
- 7 Water leakage to the environment

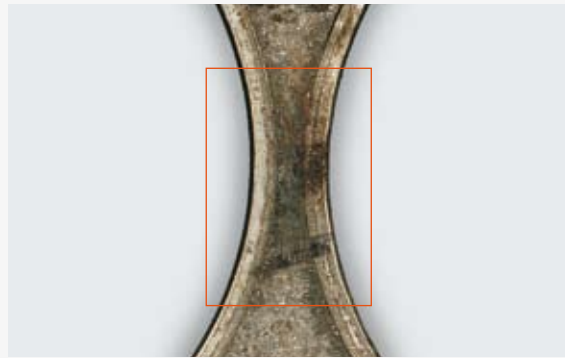
▲ Gas leakage with local blackening of the fire ring bead.

The most common type of damage to composite head gaskets involves gas leakage with blackening of the fire ring, which is relatively easy to detect on a disassembled gasket. Slight blackening at this location due to thermal loading and micro leaks is normal. However, local blackening can be an indicator for real gas leakage, which will ultimately result in destruction of the fire ring due to blowby of hot combustion gases. In this case, the gasket material under the fire ring bead loses its elastic properties due to the high thermal loading. The result is leakage.

Gas leakage with blackening can be the result of insufficient sealing surface pressure or an overheated engine.

Possible causes for insufficient sealing surface pressure are faulty or reused cylinder-head bolts, incorrect torque values, damaged cylinder head and/or engine block, or non-observance of assembly instructions.

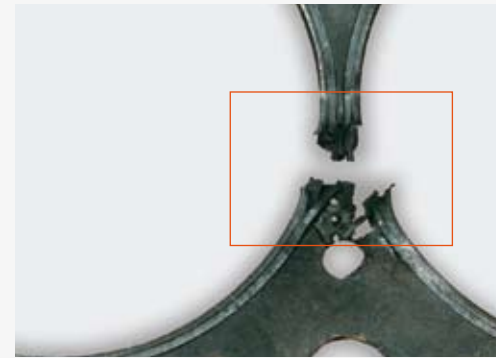
▲ Destruction in the web area due to combustion gas blowby.

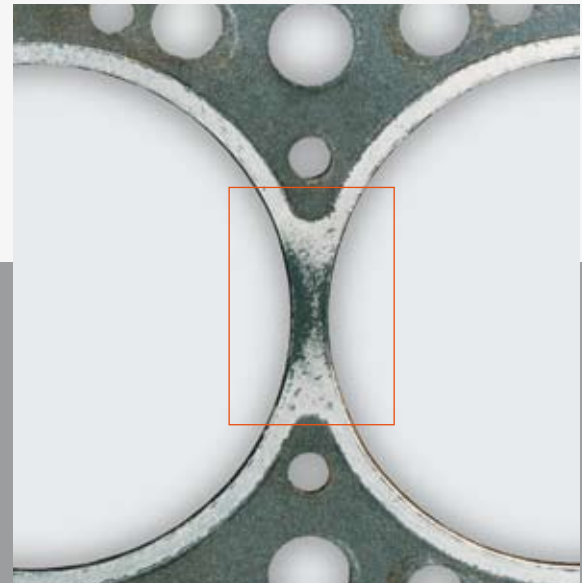
▶ Gas leakage with severe marking due to blowby of hot combustion gases.

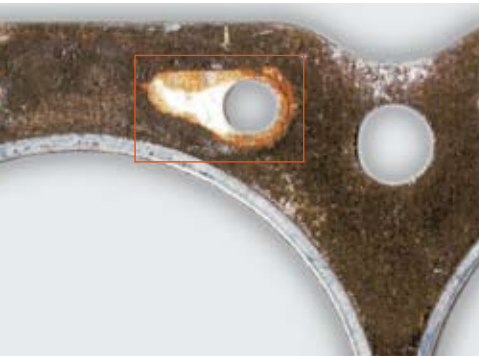
▲ Swelling of composite cylinder-head gaskets due to overheating with steam generation.

Similarly, engine overheating with simultaneous steam generation will cause damage to composite head gaskets. This kind of damage is indicated by severe swelling in the areas where the composite gasket material is exposed to the coolant in the water channels. The swelling results from the destruction of the gasket material's silicone impregnating agent, which is not resistant to steam.

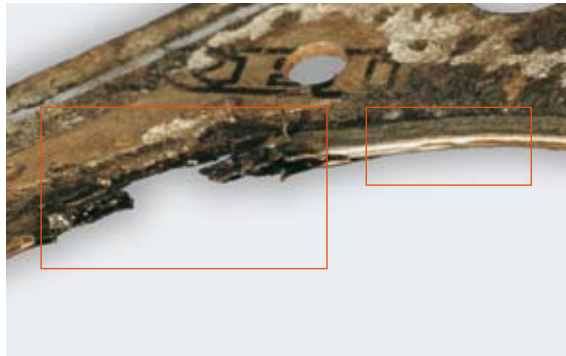
▲ Indentation and crushing due to pre-ignition – with and without blowby.

Defective composite head gaskets that exhibit indented or crushed fire ring beads have been damaged by «pinging» (pre-ignition). During this process, uncontrolled combustion causes sharp pressure increases and extremely high combustion chamber pressures. The causes for preignition are unsuitable fuels with insufficient octane rating, wrong spark plugs, incorrect ignition timing, or excessively low engine speeds over a longer period.

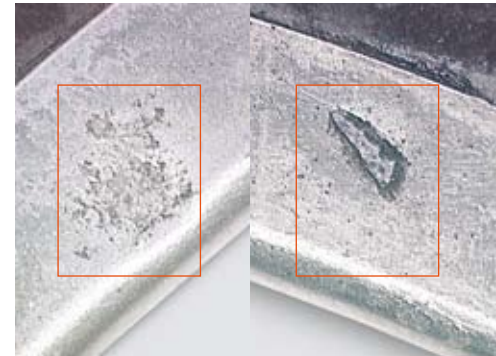
▲ Gasket damage due to dirt and foreign objects.

Practice shows that reference to the importance of clean surfaces is necessary. Repeatedly, pressed-in dirt or foreign objects are the cause for damage and leakage. Therefore, the surfaces of engine block and cylinder head should be cleaned thoroughly. This applies in particular after reworking the surfaces in

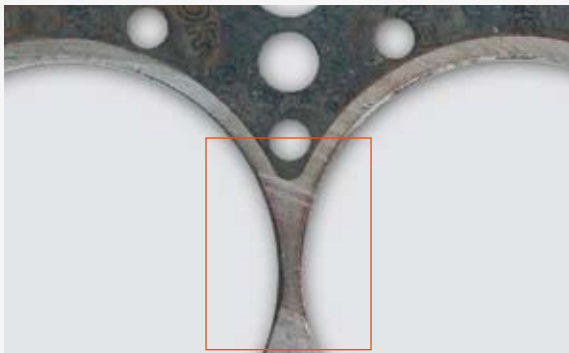
▲ *Roughness of engine block and cylinder head surfaces leads to gas blowby between the combustion chambers.*

Perfect seals with composite cylinder-head gaskets require a correspondingly high finish of the sealing surfaces. Excessive roughness of engine block and cylinder head surfaces leads to gas blowby between the combustion chambers and inevitable failure of the head gasket.

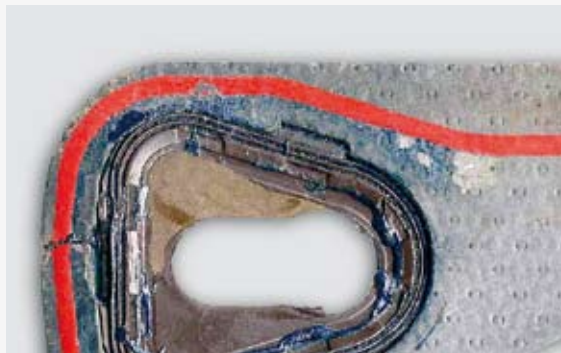
▲ *Tearing and breakage of the composite material, and damaged Viton element due to incorrect application of additional sealing compound.*

In the worst case, the use of additional sealing compounds will destroy the gasket through tearing or breakage of its composite material. In particular, this is true for the area around the Viton element because, as the engine warms up and cools down, the additional compound prevents the element expanding into the spaces provided. The results are tearing of the material or breakage of the Viton element.

Additional sealing compounds should only be applied if this is specified explicitly by the manufacturer
